Geomorphology

Effects of Stronach Dam removal on fluvial geomorphology in the Pine River, Michigan, United States

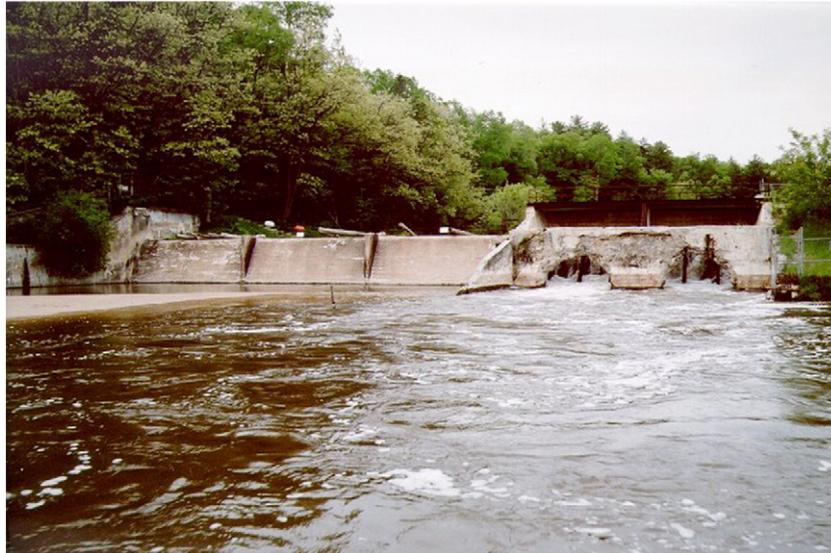
Fig. 1. Photograph of Stronach Dam in 2001, during gradual removal.

Stronach Dam was located on the Pine River, a tributary to the Manistee River, in the northwestern Lower Peninsula of Michigan (Fig. 1). The Pine River is a 77-km-long, fourth-order stream and drains a 68635-ha watershed dominated by sandy glacial outwash plains, recessional moraines, and areas of consolidated clay (Hansen, 1971; Rozich, 1998). Mean daily discharge recorded at two U.S. Geological Survey (USGS) gaging stations on the Pine River (8 and 13.7 km upstream from Stronach Dam) averaged 8.10 m³/s during 34 years of record, with a minimum discharge of 4.56 m³/s, a maximum of 69.09 m³/s, and an average annual ratio of low to high mean monthly flows of 2.02, indicating “stable to very stable” flows (Rozich, 1998). The river carries a large bedload of sand because of the local geology and extensive logging operations of the late 1800s, which exacerbated bank instability along the river. Hansen (1971) estimated a mean annual sediment discharge of 50000 tons at Stronach Dam from 1967 to 1970, which was 70–75% sand.

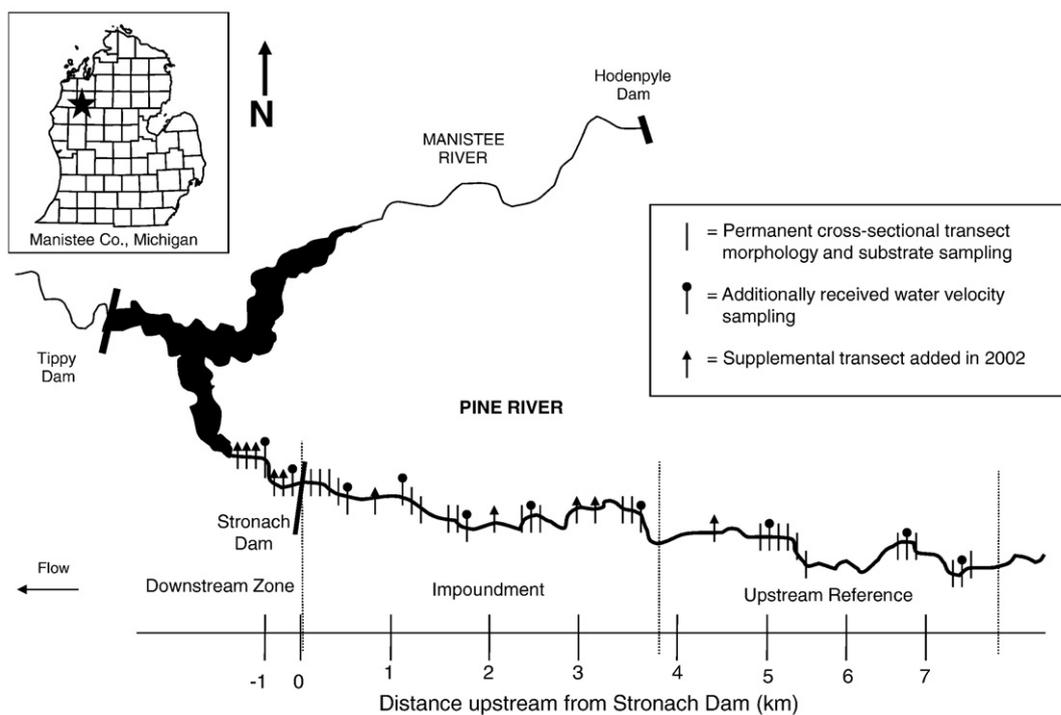
Fig. 2. Location of Stronach Dam and Pine River in relation to the state of Michigan, and the location of permanent cross-sectional surveying transects within the study area of Pine River.

Stronach Dam was constructed from 1911 to 1912, 5.6 km upstream from the confluence of the Pine River and the Manistee River (Fig. 2). Stronach Dam was originally a hydroelectric dam with an earth embankment and concrete corewall, a 4.57-m fixed-concrete spillway section with 0.91 m of flashboards on top of the spillway and a concrete and brick powerhouse with two turbine bays (Consumers Power Company, 1994). Stronach Dam, with 5.49 m of head height possible, was operated mostly around 5.18 m of head. This created a 26.7-ha reservoir with a 789428-m³ volume capacity (Hansen, 1971; Consumers Power Company, 1994). Tippy Dam (17.07 m head height), also a hydroelectric dam, was constructed in 1918 immediately downstream of the confluence of the Pine and Manistee Rivers (Rozich, 1998) (Fig. 2), which created a 428-ha, 48722530-m³ impoundment and impounded water upstream to Stronach Dam.

Water velocity was measured at 10 of the permanent transects (Fig. 2) annually from 1996 to 2006. From 1996 to 2000 a Marsh-McBirney Model 201 portable current meter was used and from 2001 to 2006 water velocity was measured using a Global Flow Probe Model FP101. Water velocity was measured at 0.61-m intervals across the wetted width of the stream. If water depth was <0.75 m, water velocity was measured at 60% of the water depth from the water surface. If water depth was >0.75 m, water velocity was measured at 20% and 80% of the water depth from the water surface, and the two measurements were averaged (Gallagher and Stevenson, 1999).

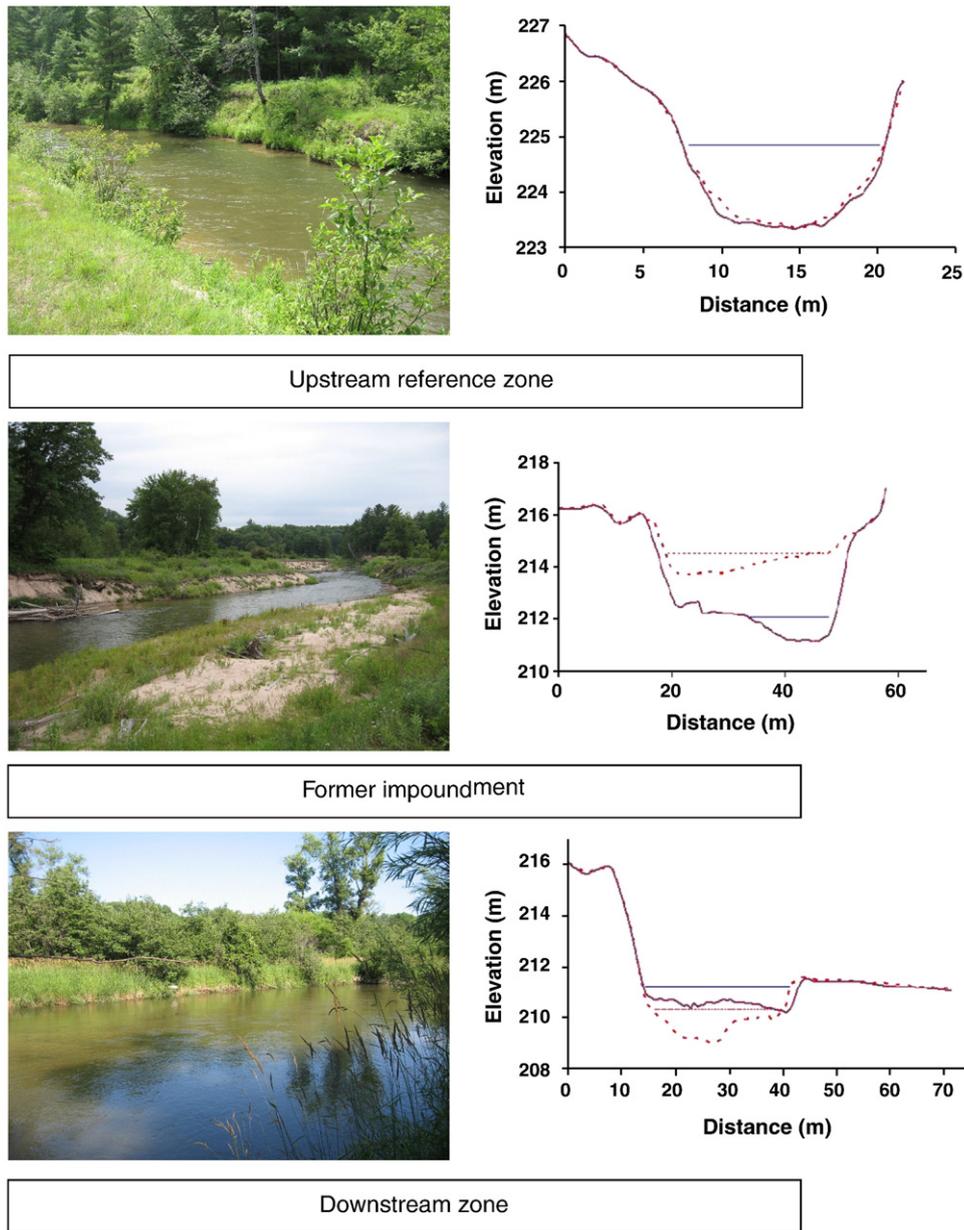
Fig. 3. Photographs and channel cross-section diagrams illustrating typical channel forms within each of the three study zones. Dashed lines indicate streambed and water surface level in 1996, prior to initiation of dam removal; solid lines represent post-dam removal, in 2006.

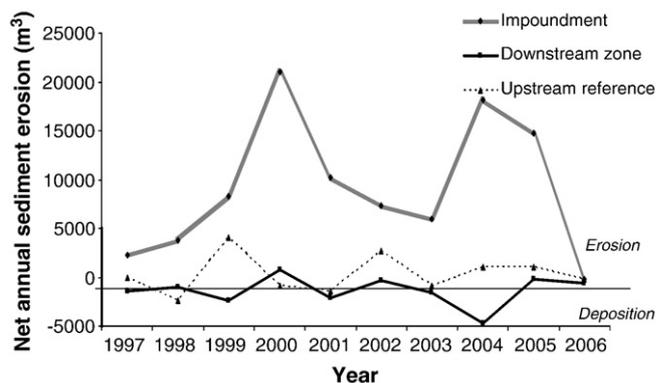
Fig. 4. Net annual sediment erosion or deposition volumes during and after the staged removal of Stronach Dam (1997–2003). Positive values correspond to net erosion; negative values correspond to net deposition.

The total volume of sediment eroded from the impoundment during the staged removal through three years post-removal was ~92 000 m³. The annual volume of sediment eroded from the impoundment averaged 9159 m³ and was quite variable with a standard deviation of 6947 m³ and a range from ~0–21 000 m³ (Fig. 4). In 2006, no net erosion occurred in the impoundment. Although the amount of mean annual sediment erosion was large, it was still substantially less than the mean annual bedload estimated by Hansen in 1971 at the Stronach Dam site. Hansen estimated that over three years, the mean annual bedload was 50 000 tons, or ~28 000 m³ (using a density of 1.8 g/cm³ for sand; Morris and Fan, 1998). This makes the total net amount of sediment erosion from the former impoundment over the 10 years during and post-dam removal roughly equivalent to about 3.5 years of annual sediment bedload during the time of Hansen's estimates.

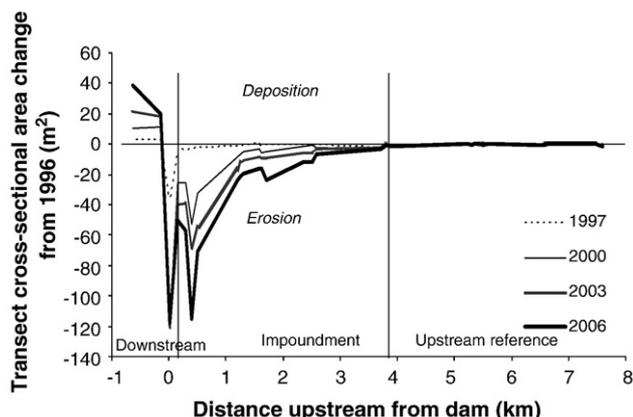
Fig. 5. Longitudinal pattern of change in cross-sectional area during the staged removal of Stronach Dam (1997–2003) compared to before dam removal (1996). Positive values correspond to deposition within a transect; negative values correspond to erosion at a transect.

The amount of erosion, or change in transect cross-sectional area that occurred in the impoundment varied spatially with distance from the dam (Fig. 5). In general, greater amounts of erosion occurred closer to the dam site with the magnitude of erosion attenuating upstream. During the first several years of the removal, erosion progressed upstream only through the easily recognizable former reservoir (1.21 km), and it was not until 2001–2002 that net erosion was documented at the farthest upstream extent of the original impoundment, 3.89 km from the dam. A pair of transects, 0.39 and 0.50 km upstream of the dam, provide an exception to the longitudinal pattern of diminishing erosion with distance upstream of the dam. These two sites experienced greater amounts of erosion than other sites closer to the dam because of large amounts of lateral erosion in addition to vertical erosion.

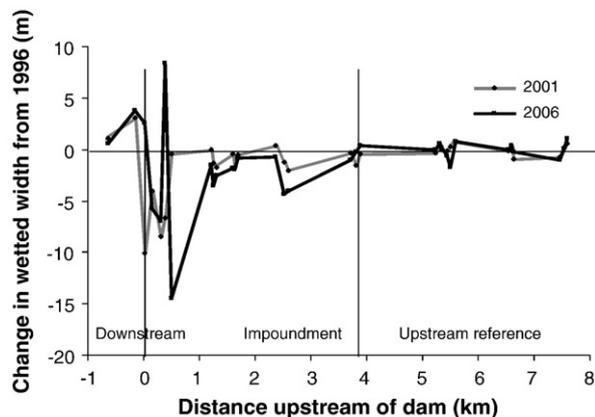
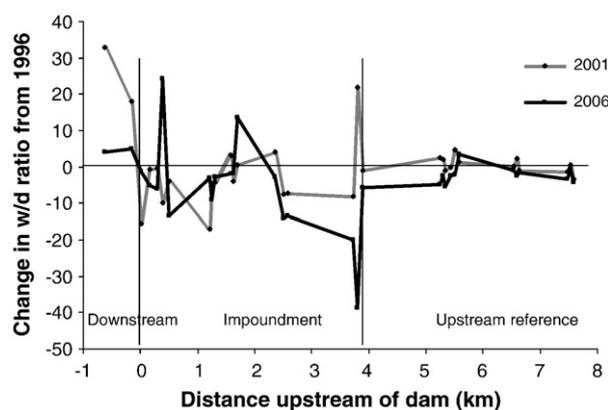
Fig. 6. Longitudinal pattern of change in wetted stream width from pre-dam removal conditions in 1996. Only 2001 and 2006, 5 and 10 years after the beginning of dam removal, are shown for simplicity and clarity.

Fig. 7. Longitudinal pattern of change in wetted stream width to mean depth ratio (w/d) from pre-dam removal conditions in 1996. Only 2001 and 2006, 5 and 10 years after the beginning of dam removal, are shown for simplicity and clarity.

In the upstream reference reach, width and width-to-mean-depth ratio (w/d) of the wetted stream channel remained stable (Figs. 6 and 7). In the impoundment, the width of the wetted channel generally decreased (Fig. 6), with the magnitude of this narrowing generally corresponding to the amount of erosion that occurred at a transect (greatest closest to the dam and diminishing upstream through the impoundment). Localized differences in geology and slope influenced this general pattern at some transects, however. Change in the w/d ratio of the impoundment did not show any easily discernable patterns (Fig. 7). In the downstream reach, width and w/d ratio both increased (Figs. 6 and 7).

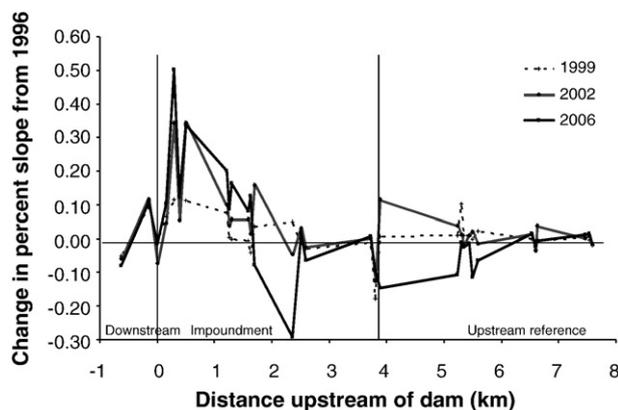
Fig. 8. Longitudinal pattern of change in bank slopes from pre-dam removal conditions in 1996.

In the upstream reference reach, bank slopes at some transects remained stable while several others were quite dynamic, showing both increases and decreases in slope (Fig. 8). Because the streambed in this reach was stable during the study period, these changes are likely due to lateral erosion processes common to streams in this area. Bank slopes in the impoundment gradually increased during the dam removal, with the greatest increases seen closest to the dam (Fig. 8). In 2006, bank slopes farther upstream in the impoundment reach began to decrease, while those closer to the dam site remained steepened. In the downstream reach, bank slopes remained relatively stable (Fig. 8).

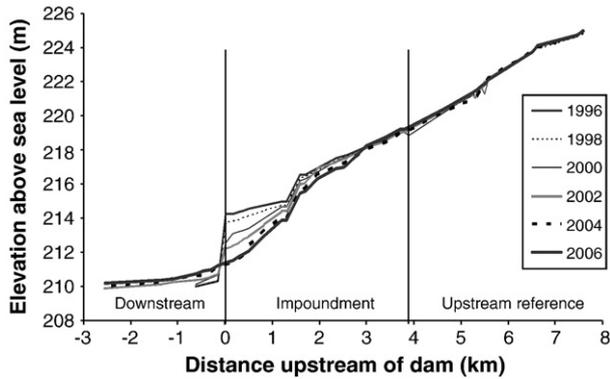
Fig. 9. Longitudinal profile of water slopes or gradients. Vertical scale exaggerated relative to horizontal scale.

As a result of the sediment erosion and deposition processes that occurred, water slope in the impoundment and downstream reaches increased during dam removal (Fig. 9). Increases in slope were greatest in the first 1.59 km upstream of the dam removal, but were observed to a lesser degree in most of the former impoundment. Slope increased in the entire impoundment from 0.13% in 1996 to 0.21% in 2006 (with 0.26% slope in the first 1.59 km upstream of the dam site in 2006). The slope in the downstream zone also increased from 0.06% in 1996 to 0.10% in 2006. Slope in the upstream reference reach remained at 0.16% in both 1996 and 2006.

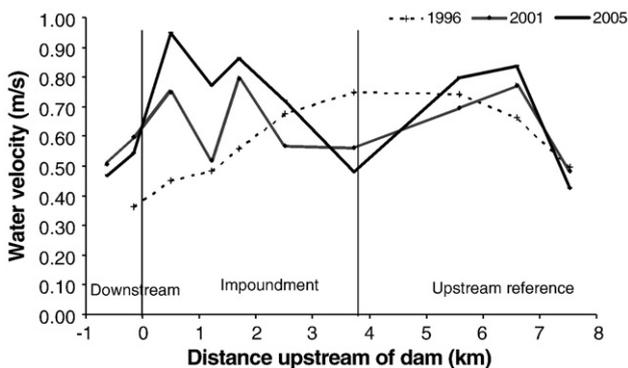
Fig. 10. Longitudinal pattern of mean water velocity (m/s) in Pine River.

Prior to dam removal, mean water velocities generally decreased in a downstream direction through the impoundment and downstream zone (Fig. 10). With the dam removal and increased slope, mean water velocity generally increased in both the lower impoundment and the downstream zone, with some of the highest mean water velocities found in the impoundment after dam removal. Because of localized differences in slope and channel morphology, mean water velocities in the impoundment were more variable after dam removal compared to before dam removal.

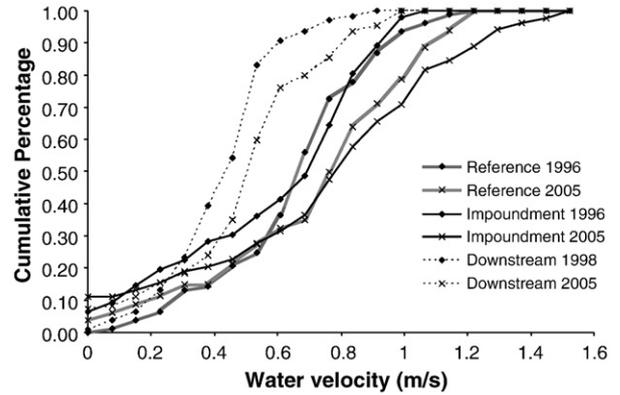
Fig. 11. Cumulative percent frequency distributions for water velocities in each study zone of Pine River.

stream margins), while the magnitude of thalweg water velocities increased (Fig. 11). The former impoundment is now the only study reach to contain water velocities > 1.2 m/s.

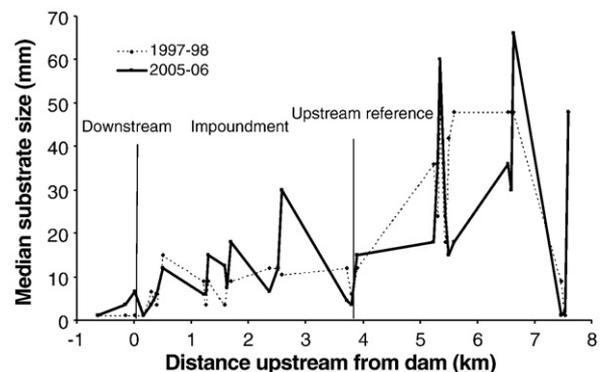
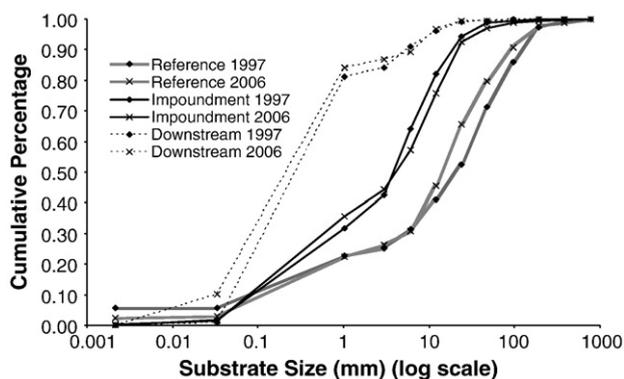
Fig. 12. Longitudinal pattern of median substrate size in Pine River, comparing 1997–1998 to 2005–2006.

Fig. 13. Cumulative percent frequency distributions for substrate size compositions in each study zone of Pine River, comparing beginning size distribution to final size distribution.

2006 = 2.3 mm = “very fine gravel”), but the overall substrate size frequency distribution for the downstream zone did not change significantly (downstream: $K-S$ test $D_{max} = 0.119$, $n_1 = 191$, $n_2 = 184$, $p > 0.01$) (Figs. 12 and 13).

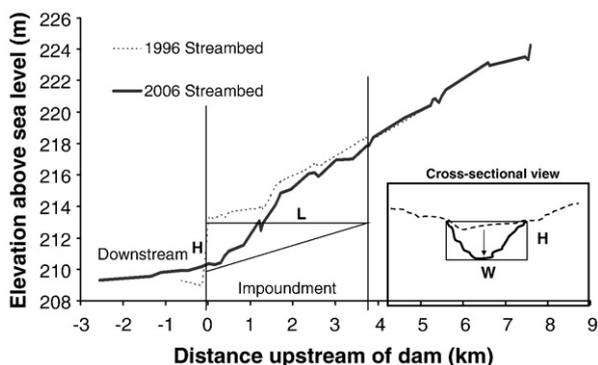
Fig. 14. Longitudinal profile of the Pine River streambed before and after dam removal. The triangle approximates the area of the sediment fill and, along with average stream width upstream of the impoundment, can be used to estimate the volume of sediment that can be mobilized at a dam removal.

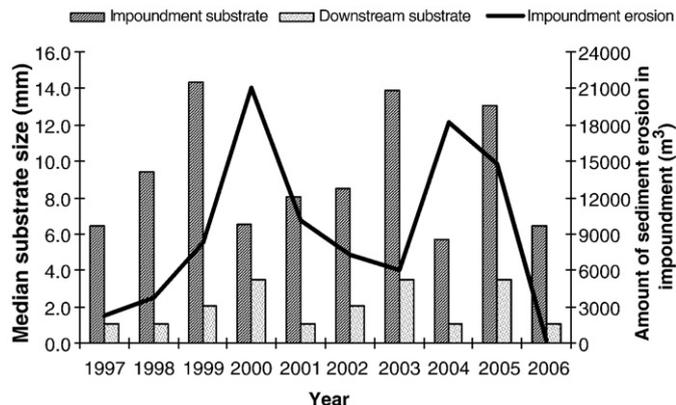
Fig. 15. Annual median substrate sizes in the impoundment and downstream study zones shown in relation to the annual amounts of sediment erosion occurring in the impoundment zone each year of the staged dam removal.

Average substrate size increased throughout most of the impoundment in response to higher slope and water velocities. Larger transient changes in median substrate size were seen during dam removal, however. Apparently during years when less than roughly 15000 m³ of sediment eroded from the impoundment, substrate coarsening progressed in both the impoundment and downstream reaches (Fig. 15). However, during years when large volumes of sediment (>15000 m³) were eroded from the impoundment (1999–2000 and 2003–2004), fine sediment was transported through these reaches, covering up previously coarsened substrate and decreasing median substrate size (Fig. 15). An exception to this trend occurred in 2006, three years after the removal, when no net sediment erosion occurred and median substrate size still decreased.
