Pigeon River Habitat

A report on the Pigeon River Fisheries Habitat Survey
July 2011

Michigan Trout Unlimited

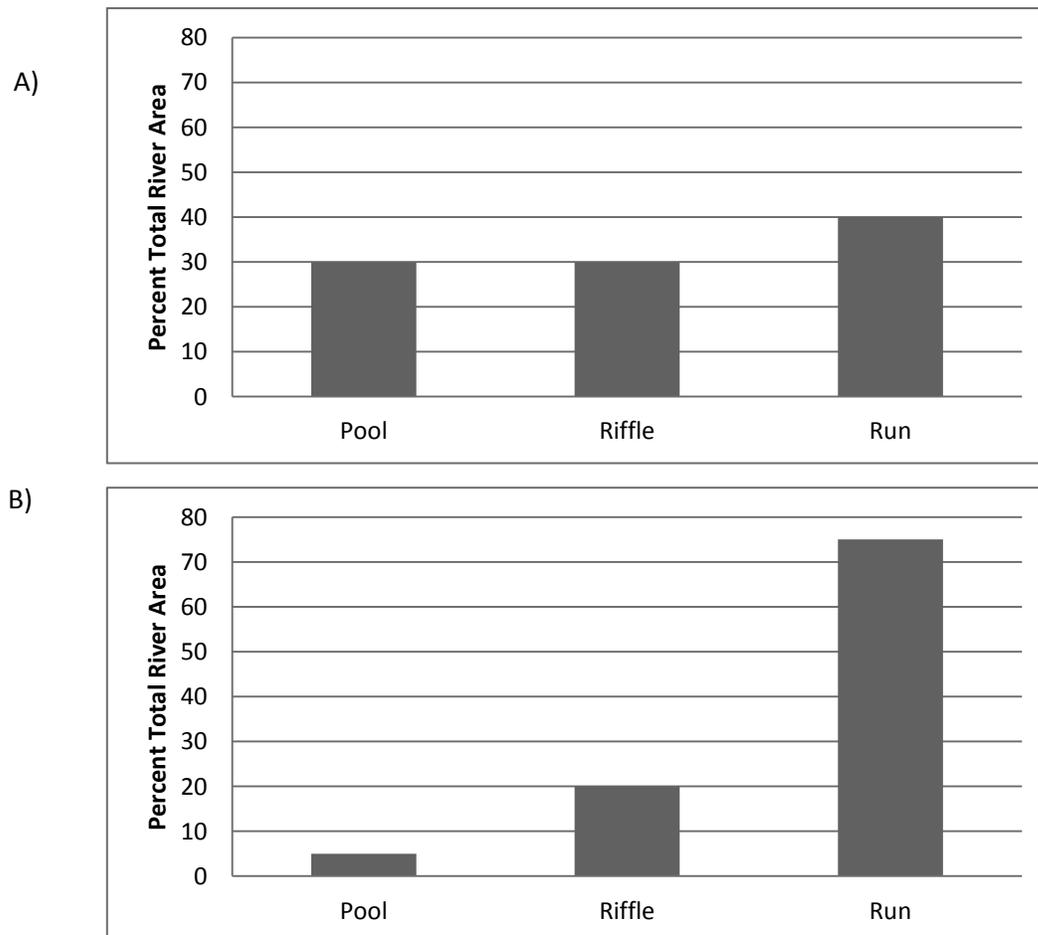
A healthy stream will have diverse bedform structure with ample run, riffle, and pool habitat. The river will not be dominated by one bedform type (Figure 1). River A has a good balance of bedform types, whereas River B is dominated by run habitat with little riffle or pool habitat available. The dominance of run habitat in river B is a sign of a problem.

Figure 1. Hypothetical bedform composition data for a healthy balanced river (A) and a river lacking bedform heterogeneity (B).

Graph A in Figures 1-3 depict a healthy river, ideally each river mapped will have data similar to that seen in the A graphs. Graph B in Figures 1-3 depict problems we are looking for when analyzing habitat data for coldwater streams. When we see data similar to that in the B graphs we know that the river is in need of restoration.

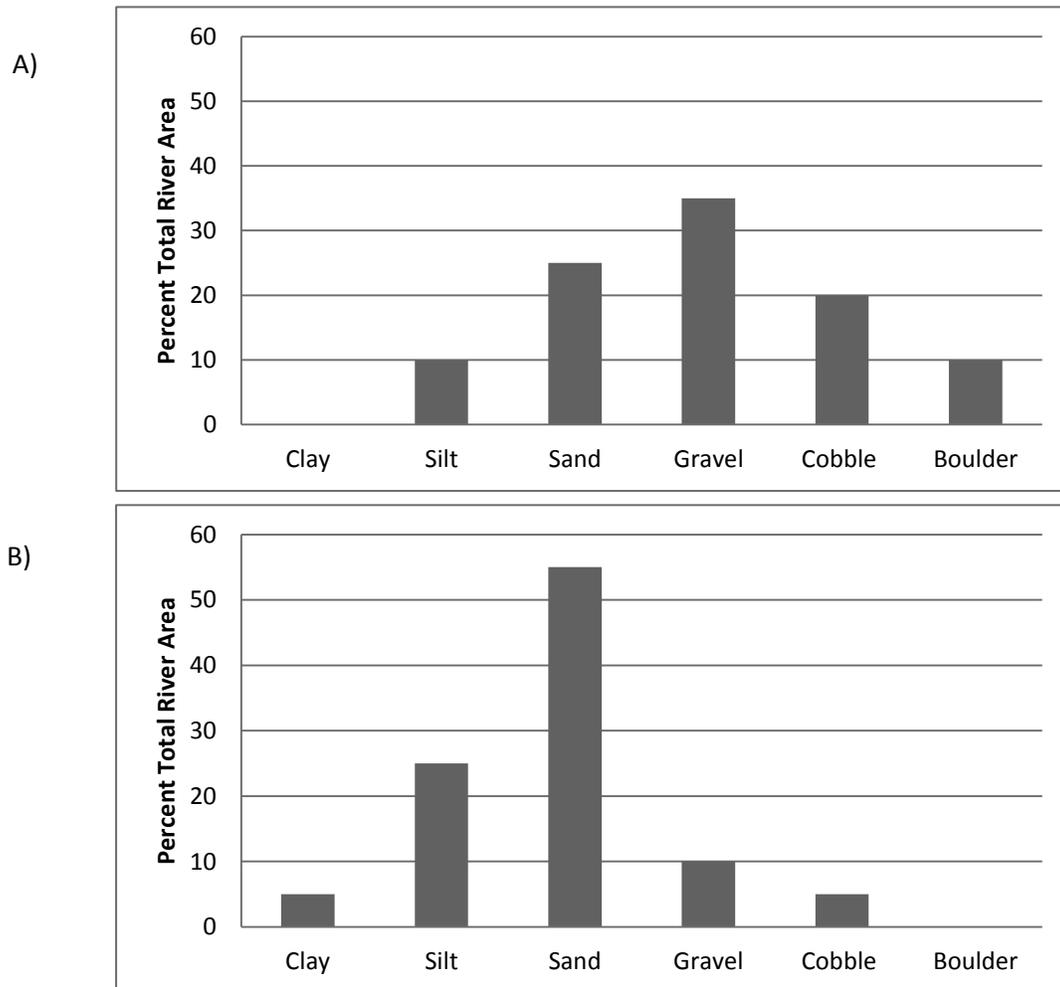
A variety of substrate types are also present in a healthy river. It is especially important that fine sediments (sand, silt, clay) do not dominate a river bottom. Erosion is a major source of pollution to our waterways, an overabundance of fine sediment can be a sign that there is an erosion problem in the watershed (Figure 2). A healthy river will have a balance of substrate types (Figure 2). River A has a good balance of fine and hard substrate; whereas river B is dominated by clay, silt, and sand with little hard substrate present.

Figure 2. Hypothetical substrate composition data for a healthy river (A), and a river with excess fine sediment (B).

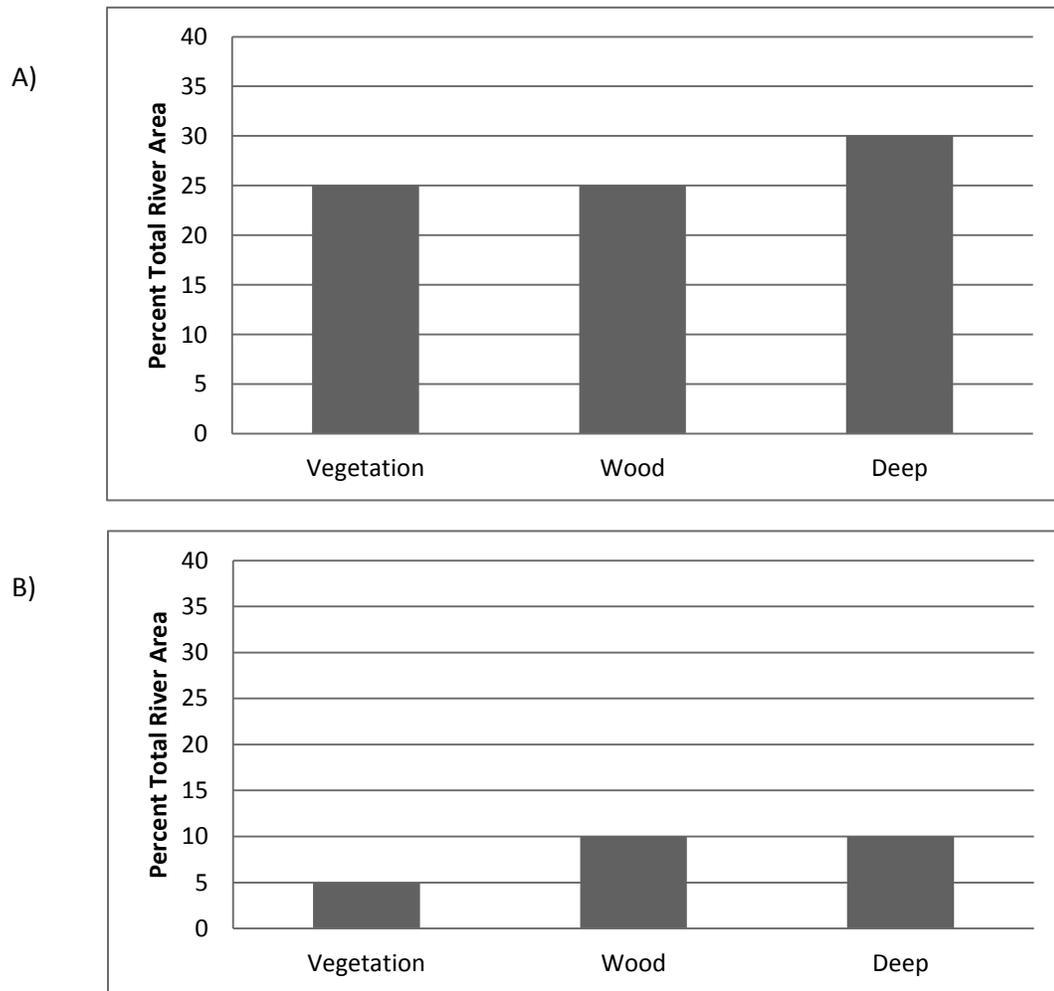
In-stream habitat diversity is also an important portion of what makes a stream ideal for coldwater fish. Fish need a variety of places to seek cover from predators including aquatic vegetation, woody debris, and deep water. A variety of in-stream habitat in much of the river is important, a lack of in-stream habitat, diversity and quantity, is a problem for fish (Figure 3). River A has abundant, diverse in-stream fish habitat (80%); whereas, river B has sparse in-stream habitat available (25%).

Figure 3. Hypothetical in-stream habitat data for a river with good diverse habitat (A), and a river lacking in-stream habitat (B).

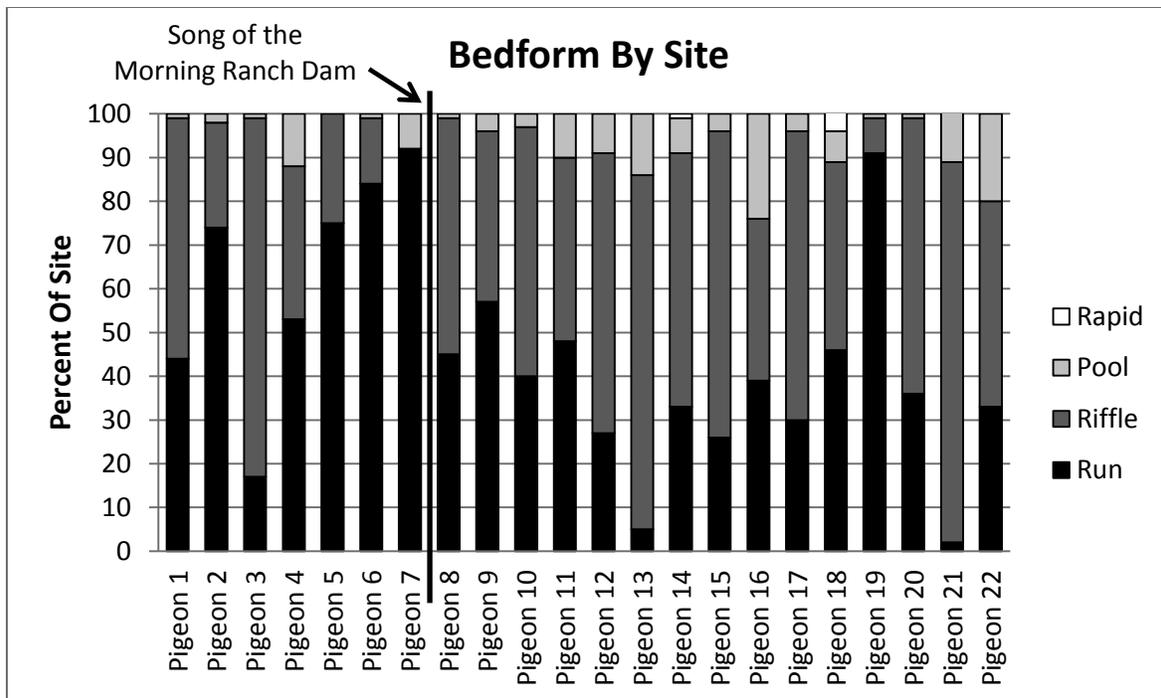
Analysis was performed on all 22 sites separately and on 3 larger sections of river. Analysis of the 22 Pigeon River sites was used to identify natural changes in river habitat. The impact of the Song of the Morning Ranch Dam is evident in river morphology. The dam is located at the beginning of site 8. Sites 5-7 are dominated by run habitat, more so than almost any other section of river (Figure 4). This overabundance of run is a result of the disruption to the natural flow of the river caused by the dam and the impact it has on the slope of the river. The impact to river morphology can clearly be seen beyond the impoundment (Figure 4).

Figure 4. Bedform delineation for the Pigeon River.

The Pigeon River as a whole has a good amount of riffle and run (Figure 5a). There is not an abundance of pool habitat throughout the river; however, there is a sizeable amount of deep water which may provide adequate habitat for larger fish (Figure 5b). Substrate in the Pigeon River is dominated by gravel (44%) with sand (27%) and cobble (16%) also accounting for a large portion of the substrate (Figure 5c). On average about 60% of the river bottom provides fish habitat (21% deep, 21% woody debris, and 21% aquatic vegetation). The most obvious impairment to the Pigeon River is the Song of the Morning Ranch Dam. The dam is having an impact on the morphology of the Pigeon River, which can be seen in the increased percentage of run in the sites above the dam (Figure 4).

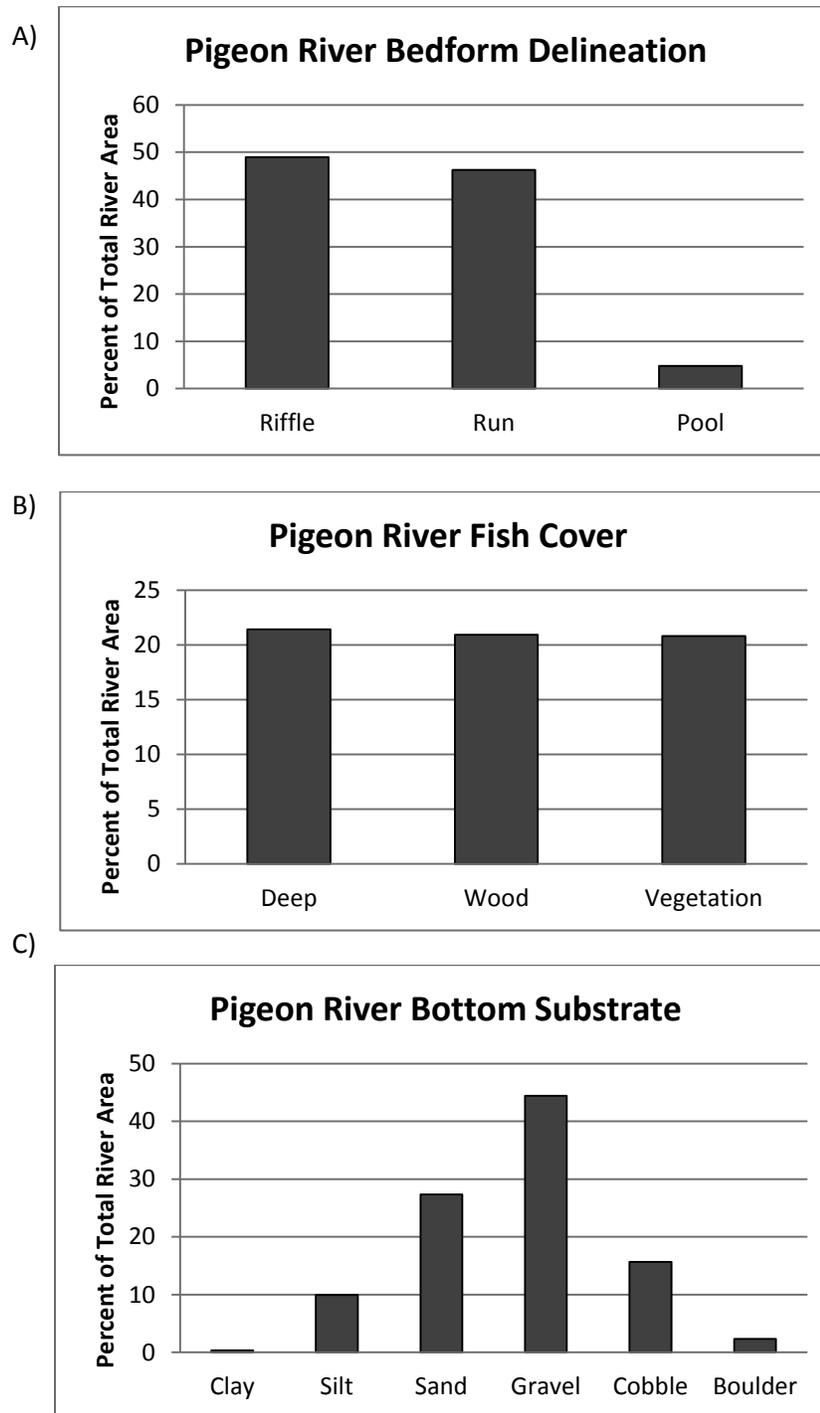
Analysis of the river as a whole appears to indicate the biggest impairment is the disruption in natural flow regime due to the Song of the Morning Ranch Dam. It is difficult to say if the river needs more fish cover (woody debris, aquatic vegetation, deep water), as data which relates coldwater fish density to amount of in-stream habitat is not available at this time. We know that trout need cover; it is less clear how much fish habitat is needed to eliminate habitat as a limiting factor.

Figure 5. Pigeon River bedform delineation, fish cover, and bottom substrate for the river as a whole.

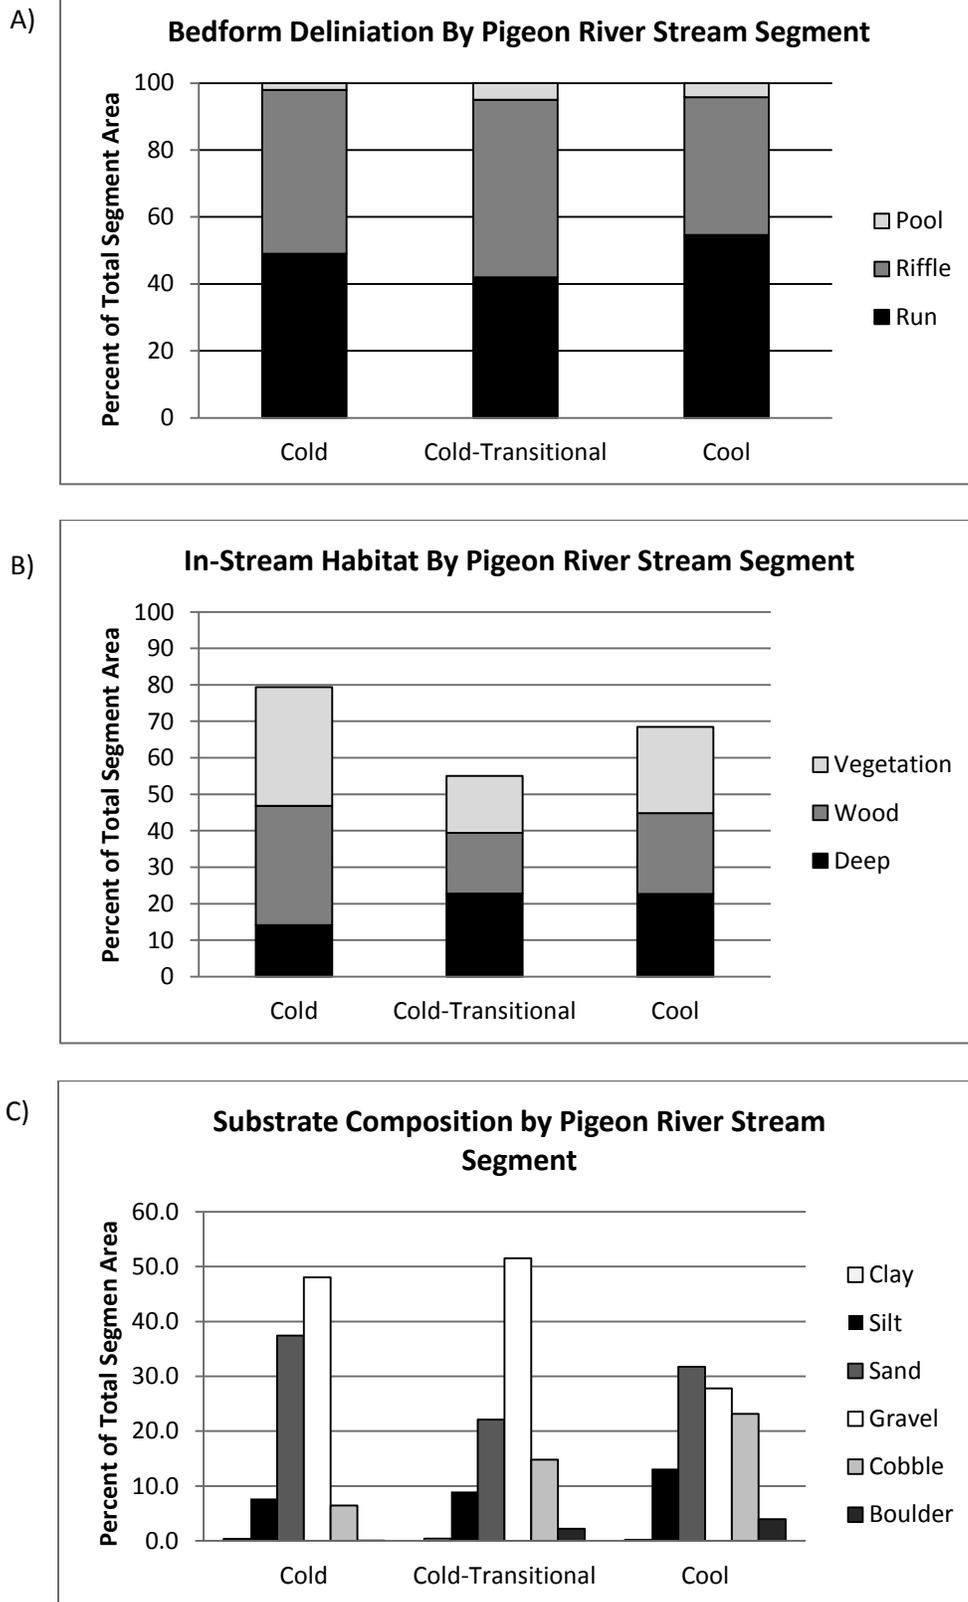
A common issue throughout the three valley segments is a lack of pool habitat. The greatest percentage of pool habitat is 6% in the cold-transitional section, the cold and cool sections have 2% and 4% respectively (Figure 6a). Although there is a clear lack of pool habitat available, there is substantially more deep water habitat available in cold, cold-transitional, and cool sections (14%, 23%, 23%, Figure 6a). Thus, there does appear to be some deep habitat available for larger fish in spite of the relative lack of pool habitat. The cold section has less deep water than the two downstream sections; this is expected as the cold section is in the upper reaches of the watershed and is a smaller headwaters type stream. Headwaters areas are often small streams with well vegetated banks. The river gets larger, and deeper as it travels downstream. There appears to be adequate riffle habitat in all sections (Figure 6a).

In-stream woody debris and aquatic vegetation seem to be relatively abundant in the cold section (Figure 6b). We would expect to see abundant woody debris and aquatic vegetation in this small, shallow, well vegetated headwaters section. The middle cold-transitional section seems to be lacking in in-stream habitat compared to the other stream sections. Again, this is expected as this section is where the Song of the Morning Ranch Dam is located. The disruption in flow caused by the dam creates a wide, shallow, monotonous stream channel with less habitat heterogeneity than other sections of river. The disruption in flow caused by the dam also limits wood recruitment upstream of the dam. The decrease in stream flow caused by the dam limits the ability of the river to move wood upstream of the dam, effectively limiting wood recruitment. When the dam is removed we would expect to see the habitat in this section improve. The cool section seems to have a relatively good mixture of habitat types available (Figure 6b).

The stream bottom is dominated by hard substrate in all three valley segments (Figure 6c). Sand is the most common substrate type in the cool section; however, when hard substrate types (gravel, cobble, boulder) are combined hard substrate is dominant (55%, Figure 6c). This cool section seems to have good substrate heterogeneity with a mixture of silt, sand, gravel, cobble, and boulder. Overall, it appears that each valley segment has adequate hard substrate available. The cold segment does have a higher than average percentage of sand (37%), but again, hard substrate is dominant (54%).

Figure 6. Bedform delineation, in-stream habitat, and substrate composition for Pigeon River Valley Segments.

When habitat and substrate are analyzed at the valley segment level it appears as though the Pigeon River has a diverse and balanced mixture of available in-stream habitat and substrate. Overall, hard substrate is dominant. Looking at some smaller sections of river and at specific stressors may help us to determine if there are any high priority restoration needs and if so where they are located.

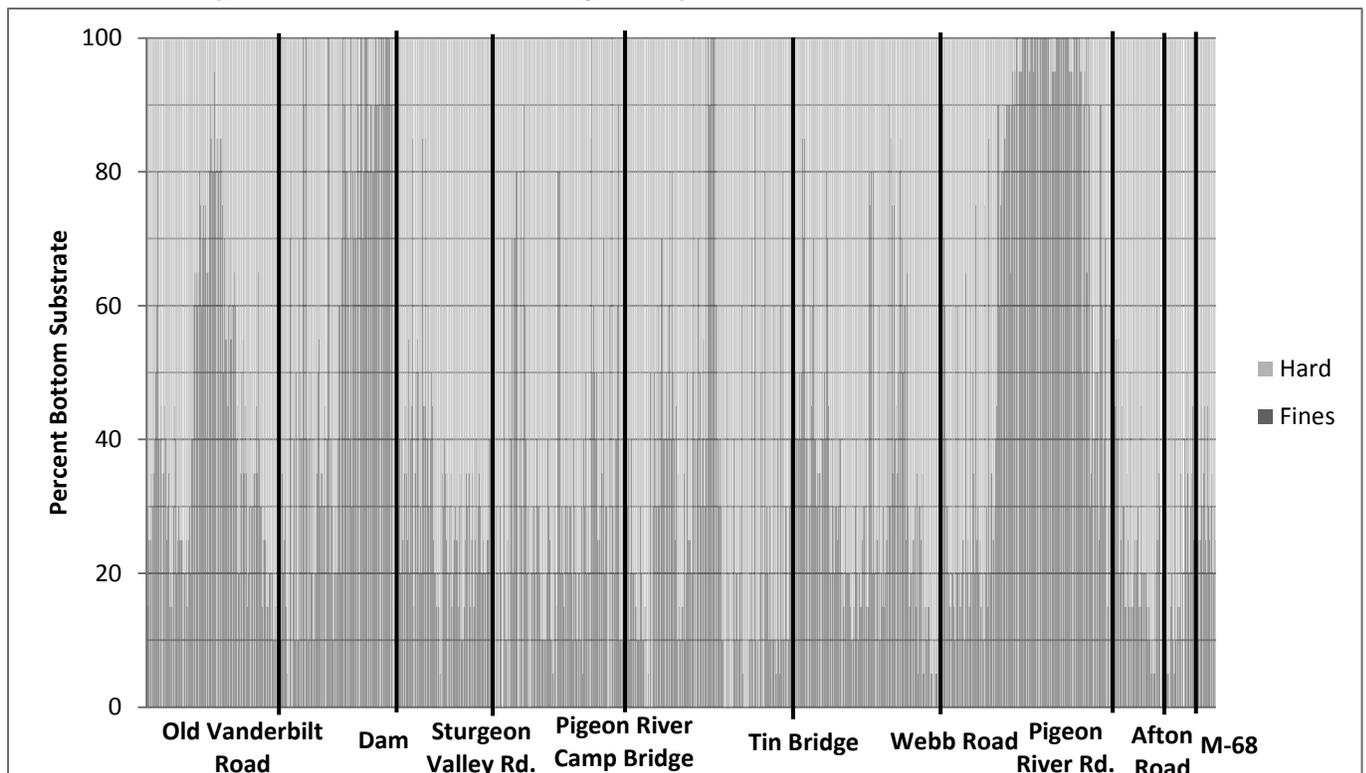
The Song of the Morning Ranch Dam is clearly the highest priority for restoration in the Pigeon River watershed. The impact of the dam can be seen in the bedform delineation of the river (Figure 4). The dam has caused excessive run habitat for a long stretch upstream (Figure 4). In addition, the impact of bottom sediment is clear. The dam stops the transport of sediment downstream leading to an increase in fine sediment upstream of dam (Figure 7). Dam removal will help restore the natural flow regime of the river and restore fish passage. As the river reestablishes channel habitat diversity, bedform and substrate diversity, will increase due to the change in slope.

Figure 7. Substrate composition (fine - clay, silt, sand and hard - gravel, cobble, boulder) for the Pigeon River. Lines indicate road stream crossings and the Song of the Morning Ranch Dam.

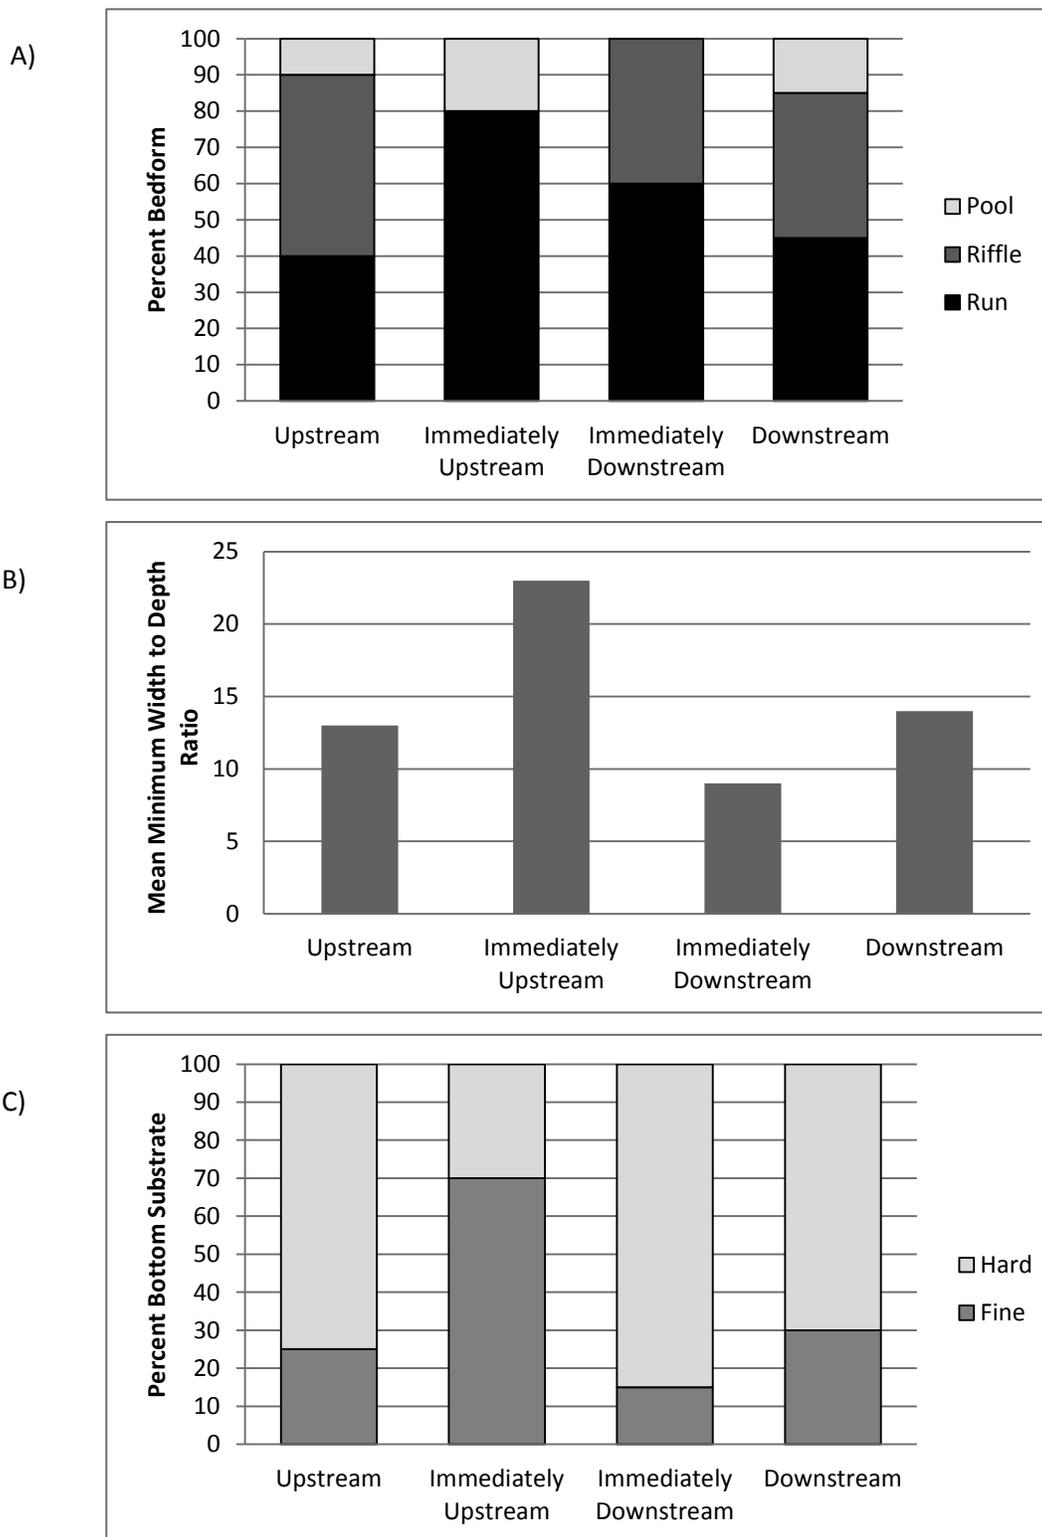
Figure 8. Hypothetical data depicting an undersized road stream crossing. A) Percent bedform upstream, immediately upstream, immediately downstream, and downstream of a hypothetical road stream crossing. B) Mean minimum width to depth ratio upstream, immediately upstream, immediately downstream, and downstream of a hypothetical road stream crossing. C) Substrate composition (Fine – clay, silt, sand and hard – gravel, cobble, boulder) surrounding a hypothetical road stream crossing.

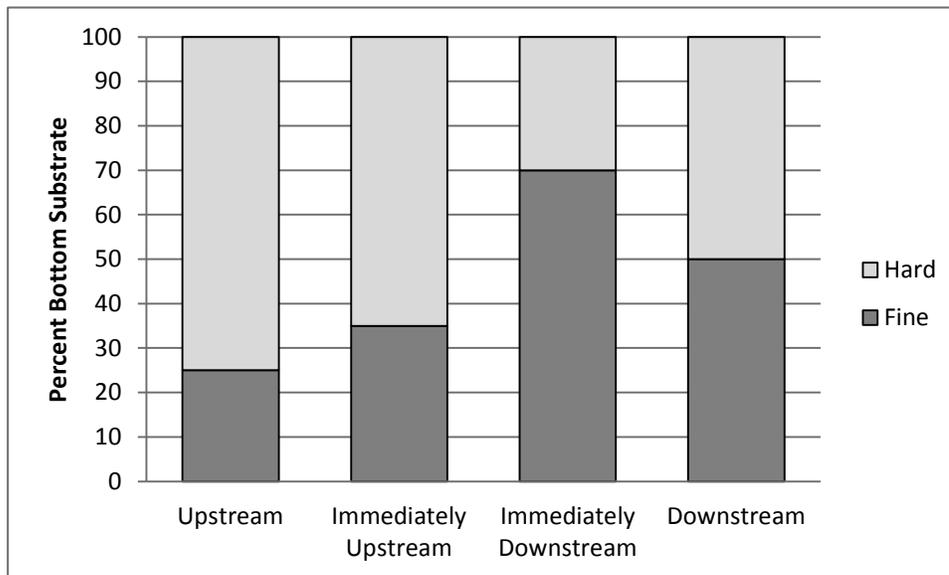
Figure 9. Hypothetical data depicting a road stream crossing at which fine sediment is entering the stream. The fine sediment category contains clay, silt, and sand. The hard sediment category contains gravel, cobble, and boulder substrates.

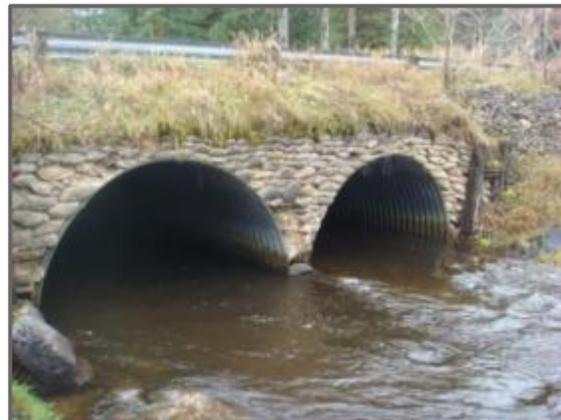
The Old Vanderbilt Road Bridge does not appear to be undersized. The stream immediately above the crossing is dominated by riffle habitat. In addition, the stream does not appear to be overly wide and shallow immediately upstream of the crossing (Figure 10). Mean width and minimum width to depth ratio are relatively consistent in all sections.

The Old Vanderbilt Road Bridge does not seem to be a substantial source of fine sediment. The streambed is dominated by hard substrate immediately up and downstream of the crossing (Figure 10). There is an increase in fine sediment in the downstream reference section compared to the upstream reference. However, it is important to note that the Song of the Morning Ranch Dam is located downstream of Old Vanderbilt Road. The increase in fine sediment is most likely due to a reduction in the slope of the river because of the dam which reduces the velocity of stream flow leading to fine sediment deposition.

Figure 10. Old Vanderbilt Road Stream Crossing. A) Percent bedform in up and downstream references reaches and immediately up and downstream of the crossing. B) Mean minimum width to depth ratio upstream of crossing, immediately upstream, immediately downstream, and downstream. C) Fine (clay, silt, sand) and hard (gravel, cobble, boulder substrate composition upstream, downstream and at (immediately up and downstream) the crossing.

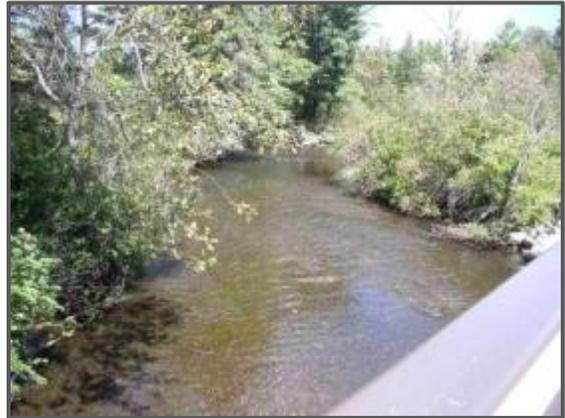
The Sturgeon Valley Road Bridge does not appear to be undersized. There is a large proportion of run habitat immediately upstream of the Sturgeon Valley Road Bridge; however, the mean minimum width to depth ratio directly upstream of the bridge is consistent with the upstream section (Figure 11) indicating that the crossing is not undersized.

The Sturgeon Valley Road Bridge does not appear to be a significant sediment source. Hard substrate is dominant in all four sections of river (Figure 8). Fine substrate occupies between 13 and 39% of the stream bottom.

Figure 11. Sturgeon Valley Bridge Stream Crossing. A) Percent bedform in up and downstream reference reaches and immediately up and downstream of the crossing. B) Mean minimum width to depth ratio upstream of crossing, immediately upstream, immediately downstream, and downstream. C) Fine (clay, silt, sand) and hard (gravel, cobble, boulder substrate composition upstream, downstream and at (immediately up and downstream) the crossing.

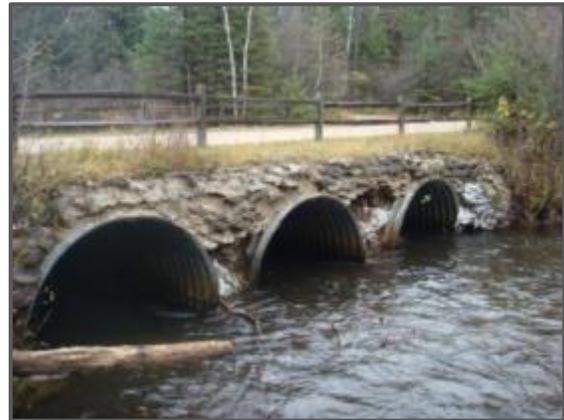
It appears that the Pigeon River Campground bridge may be restricting stream flow to some extent. Run and pool habitat are prevalent immediately upstream of the bridge as compared to the upstream section (Figure 12). In addition, riffle habitat is dominant immediately downstream of the bridge, indicating a possible flow impediment. The minimum widths to depth ratios are not what would be expected for an undersized crossing; however, further investigation is warranted.

All study sections are dominated by hard substrate. There is more fine substrate immediately upstream of and downstream of the crossing than in other sections (Figure 12). The percent fines increases from 23% upstream to 45% downstream. It is possible that fine substrate is being added to the river at the crossing and is settling out onto the stream bed downstream. This crossing was identified as a potential erosion problem in the road stream crossing inventory. Three stream bank erosion sites were identified between the Pigeon River Campground crossing and Elk Hill (end of downstream section).

Figure 12. Pigeon River Campground Road Stream Crossing. A) Percent bedform in up and downstream reference reaches and immediately up and downstream of the crossing. B) Mean minimum width to depth ratio upstream of crossing, immediately upstream, immediately downstream, and downstream. C) Fine (clay, silt, sand) and hard (gravel, cobble, boulder substrate composition upstream, downstream and at (immediately up and downstream) the crossing.

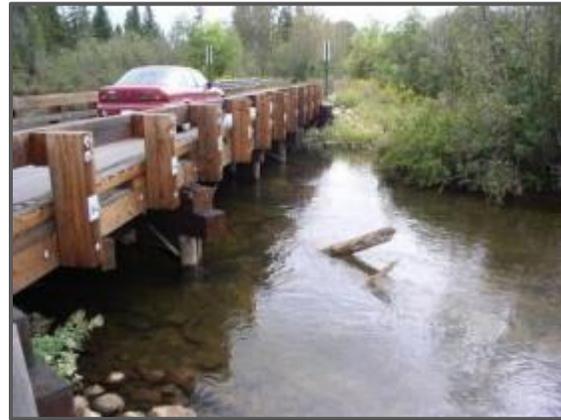
There does not appear to be a problem with the size of the Tin Bridge road stream crossing. The bedform structure does not indicate a problem with bridge size, nor does the mean minimum width to depth ratio (Figure 13).

Tine Bridge does not appear to be a significant sediment source. Hard substrate is dominant in all sections except the immediately downstream sections (Figure 13). The immediately downstream section is also nearly half pool habitat, which may explain the increase in fine sediment. Fine sediment is not elevated downstream of the crossing.

Figure 13. Tin Bridge Stream Crossing. A) Percent bedform in up and downstream reference reaches and immediately up and downstream of the crossing. B) Mean minimum width to depth ratio upstream of crossing, immediately upstream, immediately downstream, and downstream. C) Fine (clay, silt, sand) and hard (gravel, cobble, boulder) substrate composition upstream, downstream and at (immediately up and downstream) the crossing.

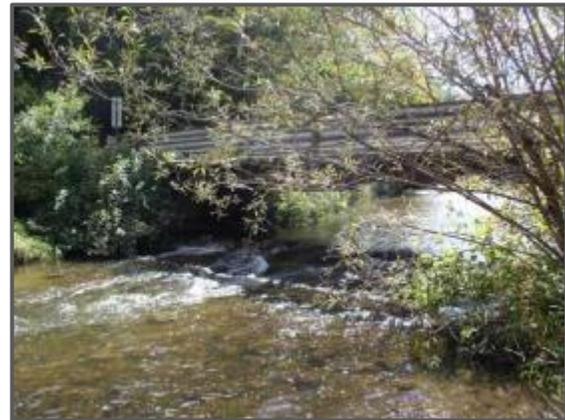
The Webb Road crossing does not appear to be undersized. Riffle habitat is dominant immediately up and downstream of the Webb Road crossing (Figure 14). Minimum width to depth ratio is elevated immediately upstream of the crossing (Figure 14). However, when the high minimum width to depth ratio is considered with the prevalence of riffle habitat it is clear that the crossing is not undersized.

The Webb Road crossing does not appear to be a significant sediment source. Hard substrate is dominant in all four stream sections (Figure 14). The sections immediately above and below the Webb Road crossing have less than 30% fine substrate. Fine substrate is slightly higher in the downstream sections, but it does not appear that erosion is a problem at this crossing.

Figure 14. Webb Road Stream Crossing. A) Percent bedform in up and downstream references reaches and immediately up and downstream of the crossing. B) Mean minimum width to depth ratio upstream of crossing, immediately upstream, immediately downstream, and downstream. C) Fine (clay, silt, sand) and hard (gravel, cobble, boulder substrate composition upstream, downstream and at (immediately up and downstream) the crossing.

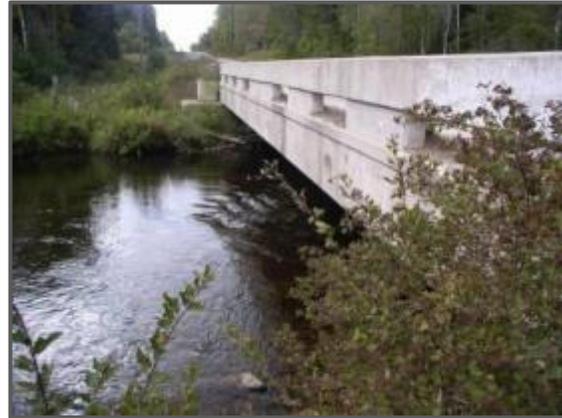
The Pigeon River Road Bridge appears to be adequately sized. Run habitat is dominant in all four river sections, especially the two upstream sections (Figure 15). Minimum width to depth ratio increases in a downstream directions (Figure 15). These two pieces of information indicate that the crossing is properly sized.

The Pigeon River Road crossing does not appear to be a significant sediment source. The percent of fine substrate decreases in a downstream direction (Figure 15). The upstream section is dominated by fine substrate. There is an overabundance of fine sediment upstream of the Pigeon River Road crossing; however this is not due to impacts from the crossing. Six erosion sites were identified between Webb Road Bridge and Forest Rd. 14, upstream of Pigeon River Road.

Figure 15. Pigeon River Road Stream Crossing. A) Percent bedform in up and downstream references reaches and immediately up and downstream of the crossing. B) Mean minimum width to depth ratio upstream of crossing, immediately upstream, immediately downstream, and downstream. C) Fine (clay, silt, sand) and hard (gravel, cobble, boulder substrate composition upstream, downstream and at (immediately up and downstream) the crossing.

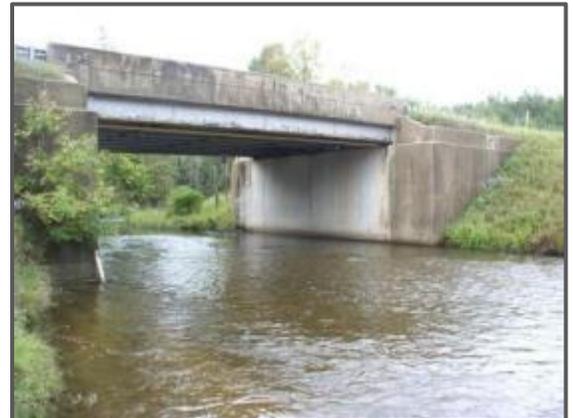
Bedform structure and minimum width to depth ratio around the M-68 crossing do not point to a problem with bridge size (Figure 17). Riffle habitat is dominant upstream, immediately upstream, and immediately downstream of the crossing.

Hard substrate is dominant above, below, and at the crossing (Figure 17). There is slightly more fine sediment immediately downstream and downstream of the crossing than upstream (30% downstream 15% immediately upstream). However, there is also more pool habitat downstream of the crossing; therefore the increase in fine sediment is most likely a natural variation in the river bottom.

Figure 17. M-68 Road Stream Crossing. A) Percent bedform in up and downstream reference reaches and immediately up and downstream of the crossing. B) Mean minimum width to depth ratio upstream of crossing, immediately upstream, immediately downstream, and downstream. C) Fine (clay, silt, sand) and hard (gravel, cobble, boulder) substrate composition upstream, downstream and at (immediately up and downstream) the crossing.

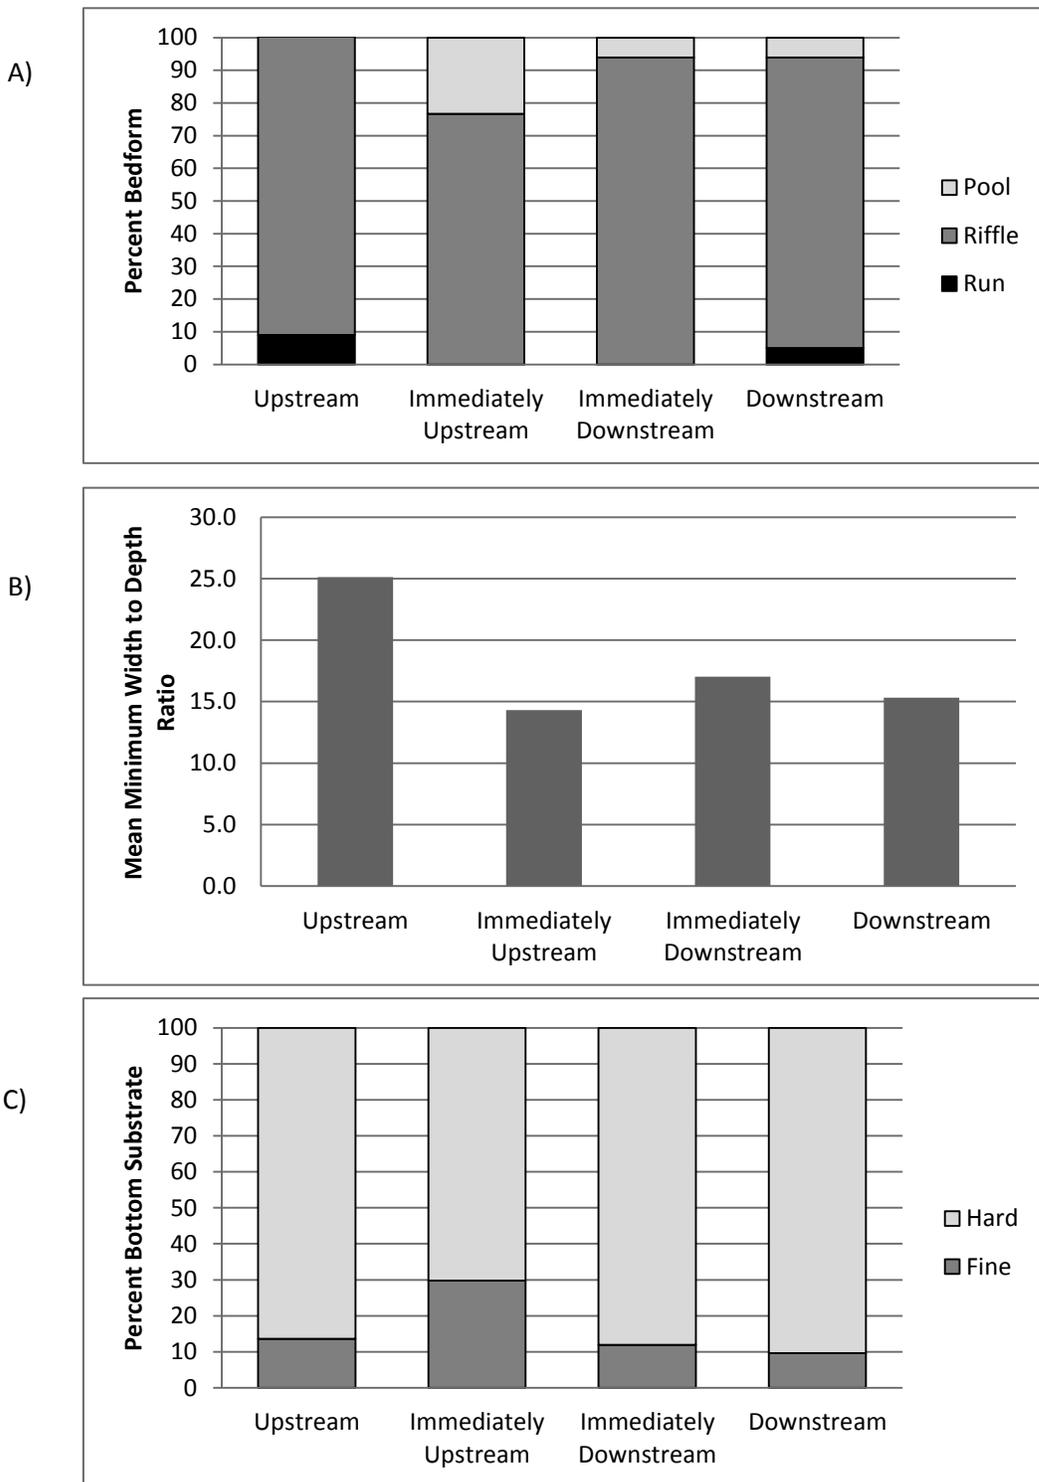
The crossing does not appear to be undersized. Riffle Habitat is dominant above, at, and below the Afton Road Bridge (Figure 16). Additionally, the minimum width to depth ratio is relatively consistent immediately above, below, and downstream of the crossing, upstream the river appears to be wider and shallower (Figure 16).

It does not appear that significant erosion is occurring at the Afton Road crossing. Hard substrate is dominant in all river sections (Figure 16). Fine substrate peaks immediately upstream of the crossing at 30%.

Figure 16. Afton Road Crossing. A) Percent bedform in up and downstream reference reaches and immediately up and downstream of the crossing. B) Mean minimum width to depth ratio upstream of crossing, immediately upstream, immediately downstream, and downstream. C) Fine (clay, silt, sand) and hard (gravel, cobble, boulder) substrate composition upstream, downstream and at (immediately up and downstream) the crossing.

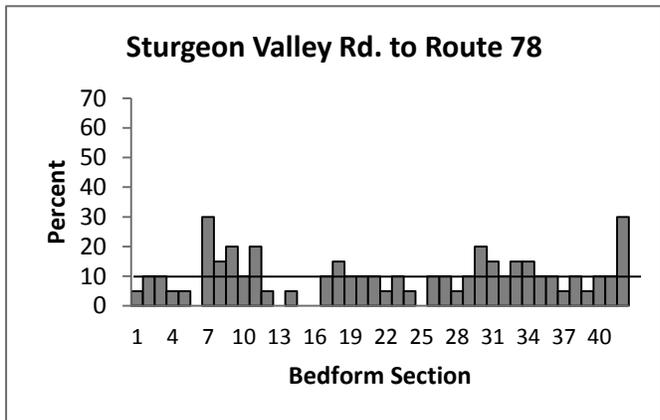
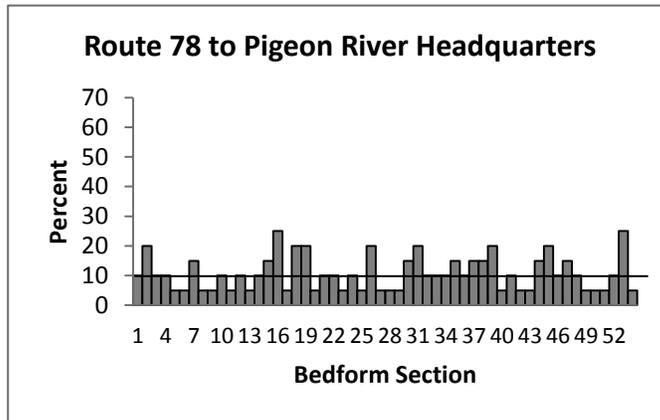
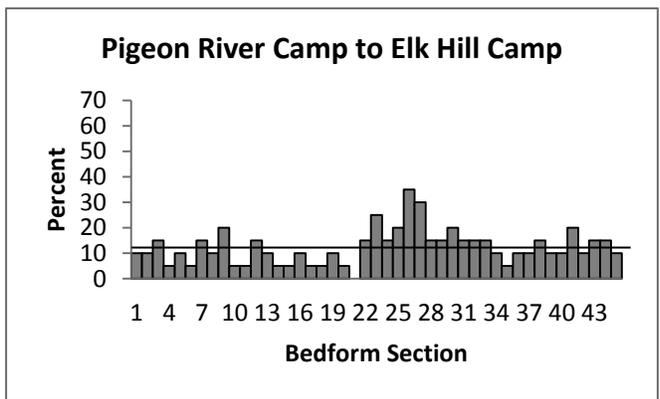
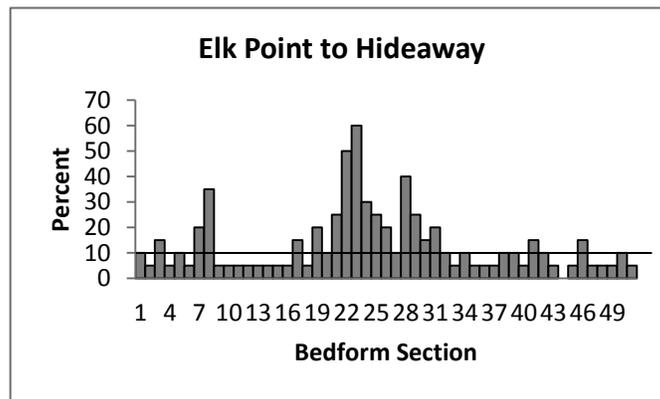
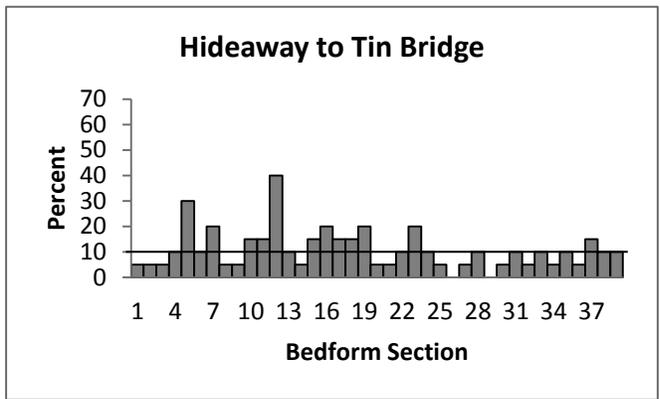
Figure 18. Percent river bottom occupied by wood by bedform section in sites with 10% wood or less.
